Intel[®] Ethernet Controller X710/ XXV710/XL710

Specification Update

July 2018

Revision 3.4
331430-014

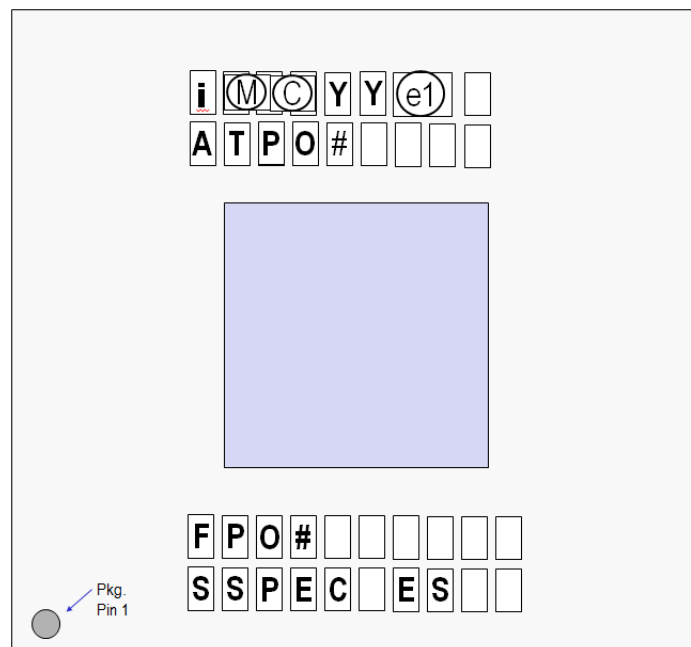
Figure 1-2 Marking Diagram

- LINE1: I, Maskwork, Copyright, YY, Pb-free
- LINE2: ATPO#
- LINE3: FPO#
- LINE4: S-spec#, ES
