**White Paper**

# Processor Reorder Buffer (ROB) Timeout Debug Guide

October 2010

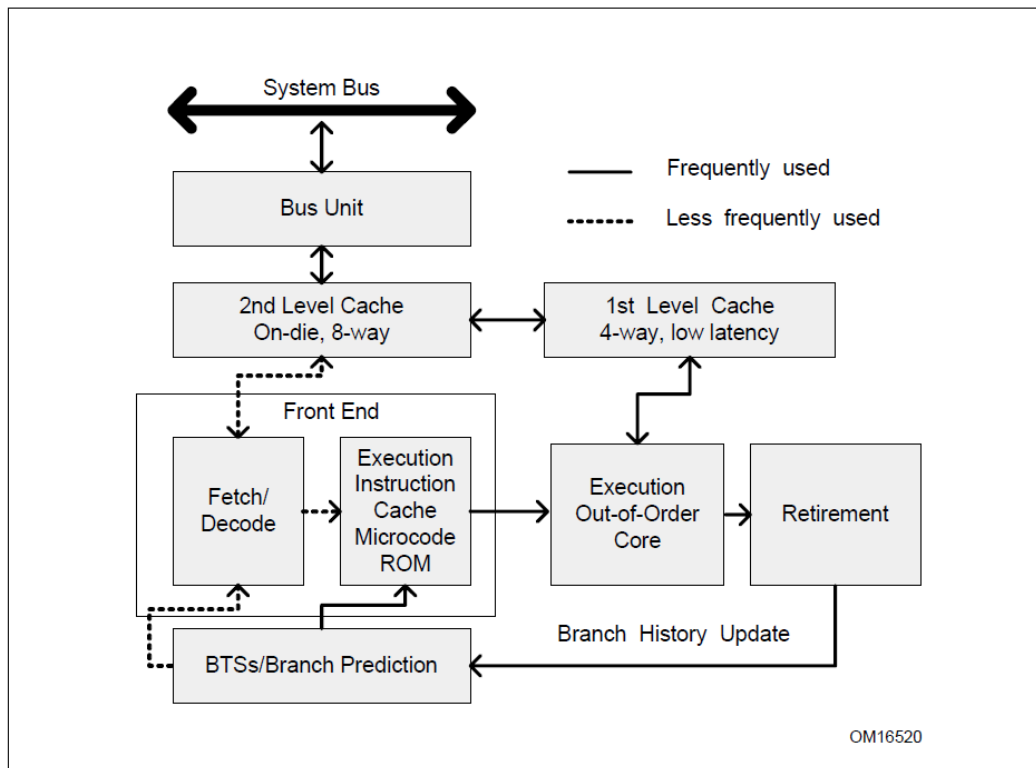
First, let's examine the meaning of a processor ROB timeout. Figure 1 is an example of a P6 Processor Micro-architecture with Advance Transfer Cache Enhancement.

Figure 1 Intel® P6 Processor Micro-architecture with Advance Cache Transfer Enhancement

From the above figure, the processor execution consists of a few blocks:

- **Bus unit** which interacts with the system bus, known as the Front Side Bus for earlier Processors, and Intel® Quick Path Interconnect for more recent processors
- **Second Level Cache unit** which interacts with the Fetch/Decode Unit and the First Level Cache unit
- **First Level Cache unit** which interacts with the Out-of-Order Execution Unit.
- **Execution Out-of-Order Core unit** which is handling out of order execution
- **Retirement unit** which is responsible for retiring processor instructions in order
- **Branch Prediction** unit which offers branch predicting hints for the processor

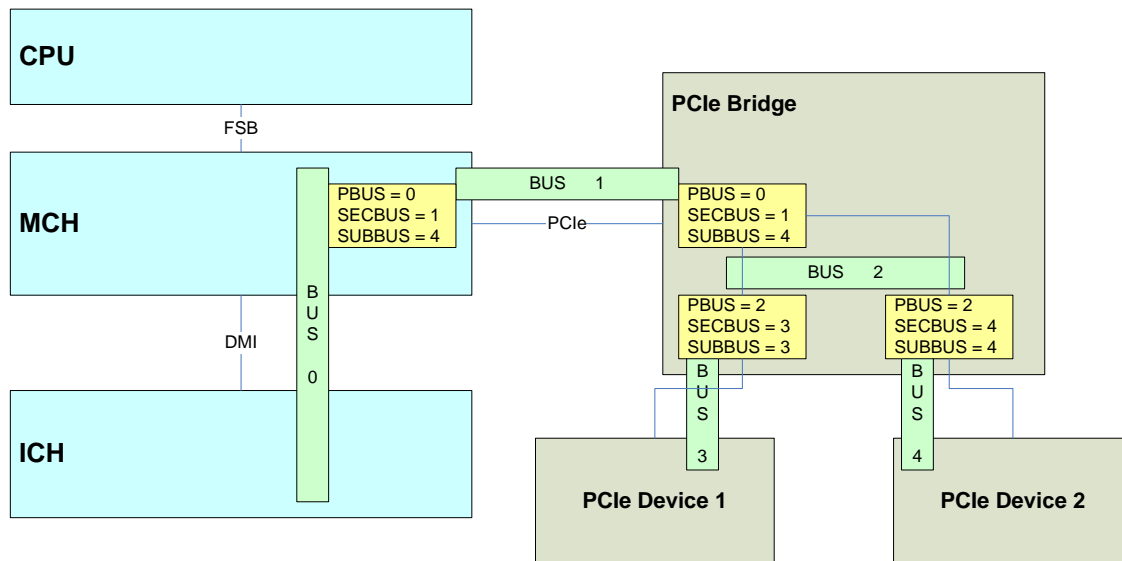
Figure 5 shows a PCI topology bus in an Intel Architecture System. The system debug engineer should be aware of accesses from the host targeting PCI Express devices in the system in order to effectively debug system issues.

Figure 5 PCI Topology Bus in an Intel® Architecture System

Based on this PCI topology, for a CPU to access PCIe Device 1, the command will have to come downstream through the PCI express Bridge before getting to the PCIe Device 1. In this example, the Flow Control Data Link Layer Packet (FC DLLP) generated by PCIe Device 1 are sent to the PCIe Bridge with a bad Cyclic Redundancy Code (CRC). Typically a single occurrence of CRC error on FC DLLP is considered a correctable error as the subsequent UpdateFC type DLLP will hold the correct Flow Control Credit available from the device. Unfortunately in this case, under certain conditions PCIe Device 1 actually generates persistent FC DLLPs all with CRC errors. As a result, the PCIe Bridge cannot send any more packets across BUS 3. This causes the downstream memory writes from the CPU to the PCIe Device 1 to be sent to the PCIe Bridge and eventually the Flow Control Credits are consumed on Bus 1. The system host (CPU) is not aware of this condition and the downstream memory writes to PCIe Device 1 continue, causing the internal queue in the Root Complex to begin filling up. The internal Command Queue in the MCH Chipset continues to fill until the Chipset backpressures the FSB and eventually there is no progress seen by the CPU so the system will see a ROB timeout event.

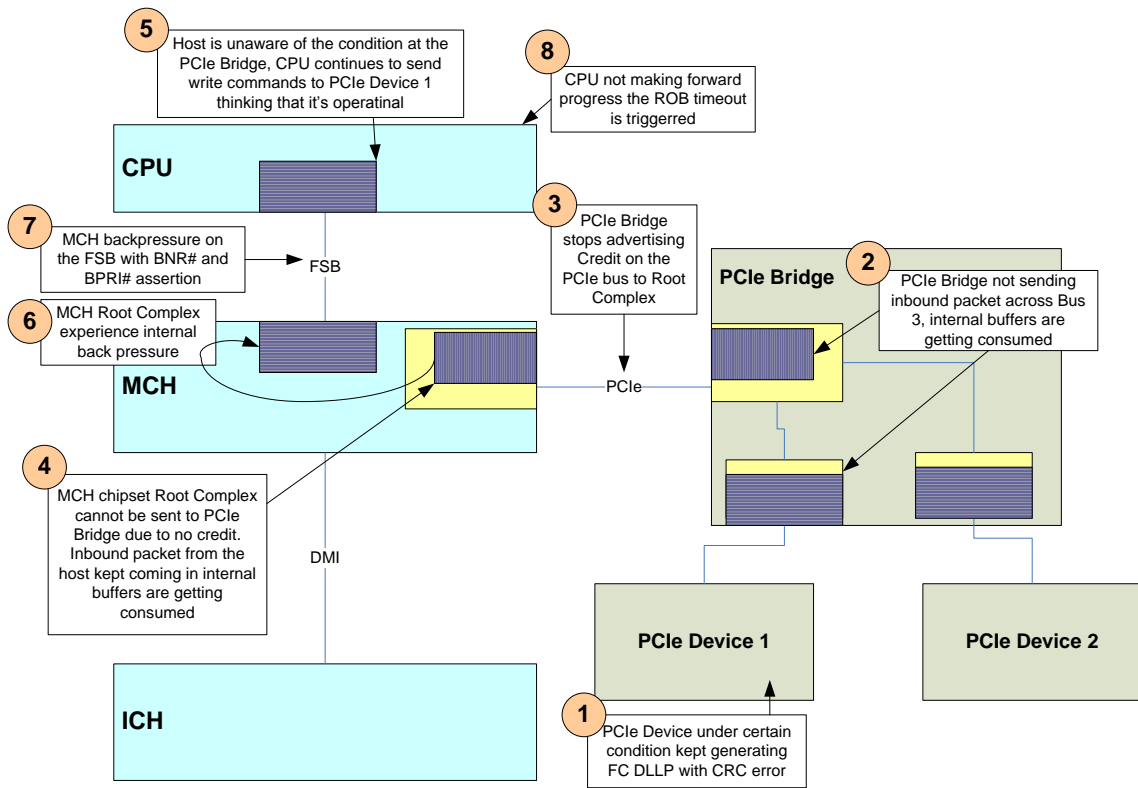
This chain of events is shown in Figure 6.

Figure 6 ROB Timeout Event

In this example, even though the PCIe completion timeout mechanism is enabled and the machine check handling software is installed, the system will still hang since even the handler software cannot be brought into the CPU for execution. The Machine Check Status register on the next warm reset will hold information indicating that the system hang is an example of the ROB timeout issue.

In debugging this ROB timeout issue, the PCIe Logic Analyzer is placed between the MCH Chipset Root Complex and the PCIe Bridge. The PCIe trace captured shows that the PCIe Memory Write transactions before the FC DLLP credit update stopped being freed up at the PCIe Bridge right before the system hangs.
